MEADVILLE AREA WATER AUTHORITY

RE: Fire Hydrant Color Coding and other information

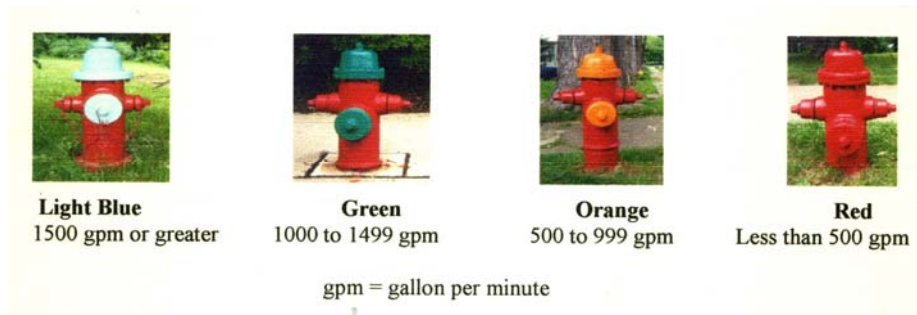
The tops and the 4" nozzle on hydrants are painted based on the tested flow rate.

- Red = Less than 500 gpm
- Orange = 500 gpm to 999 gpm
- Green = 1,000 gpm to 1,499 gpm
- Blue = 1,500 gpm

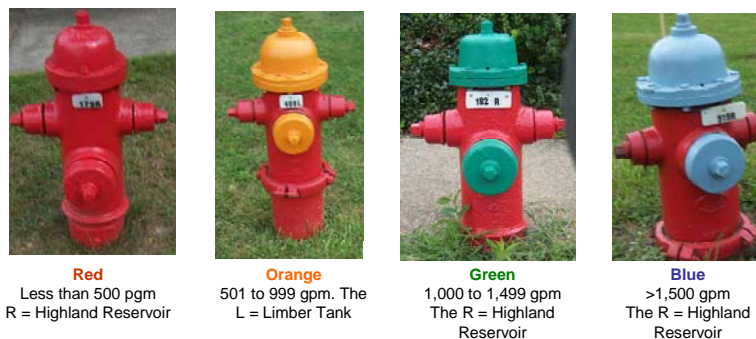
After all the fire hydrants were flow tested and painted, the Fire Chief and MAWA felt that placing a number tag would improve fire protection because the number would also be followed by a letter that designed the pressure zone; L = Limber Road Tank, R = Highland Reservoir, and H = Hillcrest Tank.

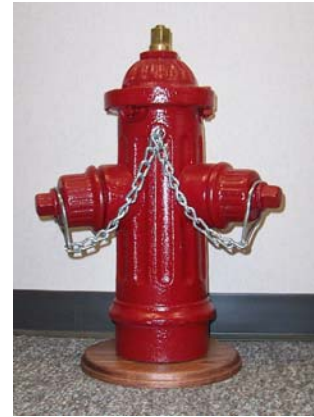
MAWA'S OLDEST HYDRANT:

Matthew Hydrant (we call it Matt and it is now located in the Board Room)

- This hydrant, removed from the corner of East College St. and North Main St. in July 2004, is the oldest hydrant of the Meadville Area Water Authority.
- The hydrant is approximately 132 years old and was manufactured between July 18, 1871 and April 30, 1872. R.D. Woods Co. was very proud of their patents and displayed their patents on the top of the rim. It is known that R.D. Woods had up to 5 patent dates cast onto the bonnet rim on some hydrants. Patent dates were the following: Jan 26, 1958, Nov 16, 1869, Reissued July 18, 1871, April 30, 1872, and Reissued Feb 26, 1984.
